## MV Hermes Leader Report

Prevention of lime scale buildup inside the heat exchanger plates of the Fresh Water Generator (FWG)

HydroPath Marine HM-120

October 21, 2015

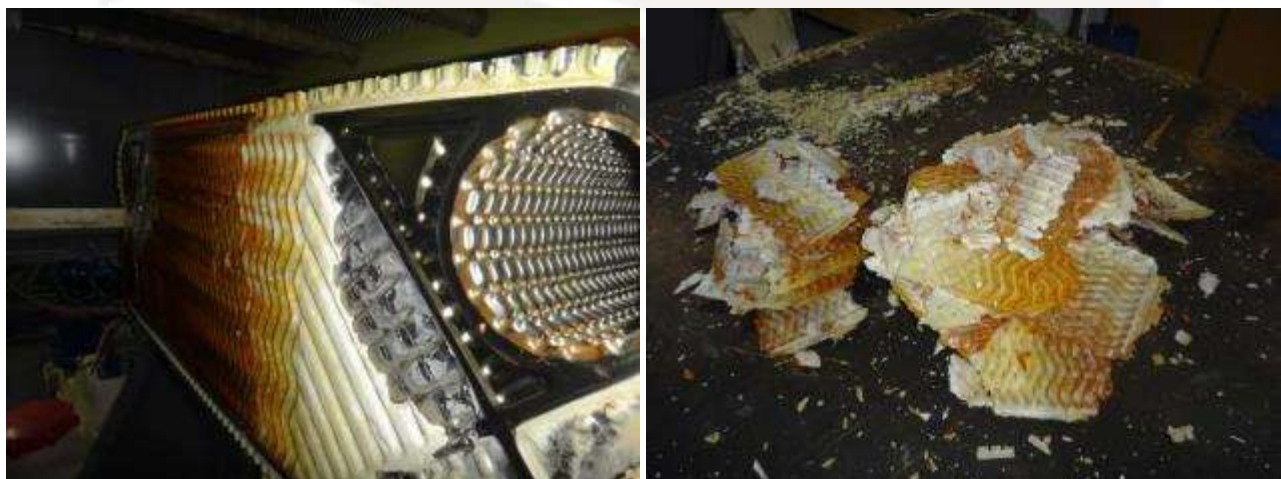
Figure 2. The Fresh Water Generator plate and the removed limescale

The FWG contained accumulated lime scale on the plates as seen in the photos above. This result is still very good since the HM unit does not prevent the formation of scale, but reduces its adhesion properties when softening the scale by means of crystallization, thus lengthening the maintenance interval and reducing downtime for cleaning significantly. When opening the FWG and the plates are taken out, most of the accumulated lime scale falls off by itself leaving only a minor rest which is easily removed by hand or with a soft brush. This way damages to the plates caused by rough scraping are prevented.

Rym 1310346 dd 21/10/2015 pls be informed that FWG evaporator has been cleaned and in operation. The production now (same condition - SW tempr, vacuum, full open heating by-pass, etc.) is 24 m3 instead of 17 m3 per 24 hrs. The salinity drops from 7-8 ppm to 1-2 ppm. 7 kgs salt was removed from plates for about 4000 rhs in service. See attached photos for reference.
